# ITS

NUMBER 22

## Interpreting The Secretary of the Interior's Standards for Rehabilitation

**Subject:** Adding New Entrances to Historic Buildings

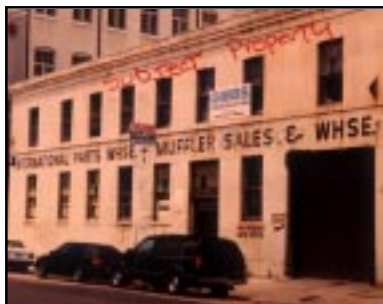
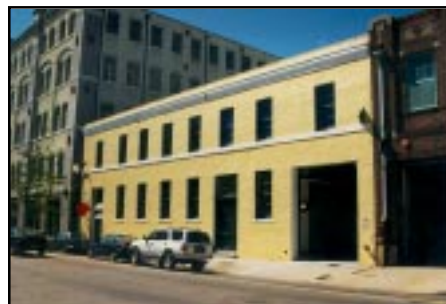
*This building was constructed with a single pedestrian entrance in 1886, and a garage door was added later (left). When the building was rehabilitated for office use, an existing window was removed from the end bay and replaced with a new glazed entryway (center and right).*

**Application 1** (*Compatible treatment*): This two-story, eight-bay masonry structure was built in 1886 as an ice manufacturing plant. Originally constructed with only one entryway, a garage door had been added later when the building served as a warehouse. As part of the building's conversion into offices, a second pedestrian entrance was added to the street elevation during the rehabilitation to make it easier to get to some of the offices. The size of the new opening is the same as that of the existing historic entrance. But, the new entrance is almost entirely glazed, and consists of a simple butt-mounted glass door with sidelights, and a single-light transom. It is clearly a compatible, contemporary design that does not draw attention to itself. It cannot be confused with the historic entrance, and it does not change the character of the building. Thus, it meets the Standards.

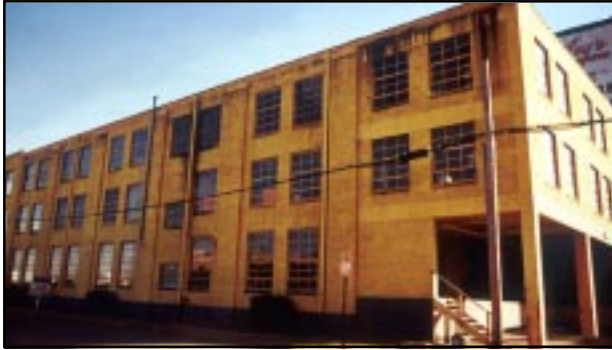
*This historic warehouse had entrances on three elevations of the building prior to rehabilitation.*

**Application 2:** A larger, free-standing, three-story warehouse building constructed in 1922, with a 1940s addition, was to be rehabilitated into commercial and retail spaces on the first floor with residential apartments on the upper floors. The building featured a loading dock on one side and three utilitarian, non-significant entrances on various elevations. As part of the rehabilitation a new entrance was proposed to be added on a side of the building that never had an entrance. An entrance on this elevation would improve visibility and access to the new shops and businesses, and it would also help increase security for the upstairs apartments since existing entrances could be restricted for residential tenant use. Accordingly, a new glass and steel entryway which reflects the industrial character of the building and its historic metal windows was designed for this side of the building. The new entrance is compatible with the character of the historic building. It is unobtrusive and it does not noticeably impact or change the appearance of this elevation or of the warehouse building as a whole.
